**MILITARY SEALIFT COMMAND****LIFEBOAT SAFETY**

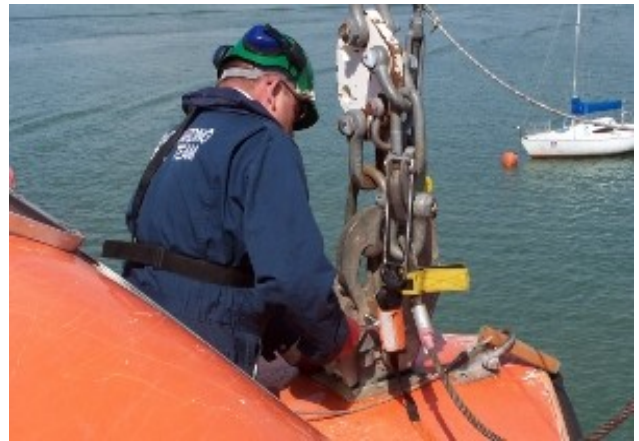
Photo from SchatHarding

In 1986, the SOLAS Convention made mandatory on-load release hooks for lifeboats and rescue boats. On-load can be defined as a method where hooks can be disengaged even if the falls and blocks are still under a load. Two safety features are built into the release mechanism to prevent that: a safety pin for the releasing handle and a hydrostatic interlock that prevents the lifeboat from being released until it is waterborne. However, on-load release hooks are inherently designed as unstable. The release system is designed to maintain the hooks in a closed position. Defects or faults in the releasing mechanism, errors by the crew or incorrect resetting of the hook after being previously operated can all result in a hook's failure and subsequent premature release.

The MAIB report mentioned on page one stated that the operating crews of the lifeboats had a poor understanding on how to operate release hooks or properly reset them after recovering the boats. Mariners need to fully appreciate the complications of on-load release hook mechanisms and ensure that the hooks are properly secured and the hydrostatic interlock system is functioning properly. In depth training on a consistent basis, clear and unambiguous instructions posted for clarity during emergency situations and taking each abandon ship drill as an opportunity to reinforce one's knowledge and skills will reduce the chances of a mishap.

In Circ. 1206, the MSC approved guidelines for periodic servicing and maintenance of lifeboats, launching appliances and on-load release gear. It is the intent of these guidelines for shipowners to employ certified lifeboat manufacturer representatives to carry out annual examination and testing of lifeboats and their releasing mechanisms. These are separate from the manufacturer's recommended weekly and monthly inspections and routine maintenance by the ship's crew. MSFSC has a number of periodic maintenance items that are specific to Lifeboat and Davit Maintenance whose periodicity should be strictly monitored. The annual servicing of lifeboats is a necessary preventative maintenance requirement that proactively seeks out changes in equipment tolerances due to operational wear and the deteriorating effects of salty air, weather and vibration.

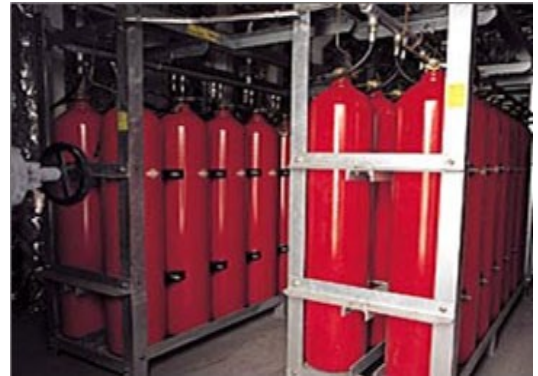
## *Fixed Carbon Dioxide*

Fixed Carbon Dioxide (46 CFR 91.25-20 and 147.65) All piping controls, valves and alarms need to be checked for proper operation and 90% charge has to be verified. The pressure drop through cylinder connections may not exceed 150 psi per minute, over a two minute period, while subjected to the 1,000 psi test pressure. Additionally, all carbon dioxide cylinders must be retested every 12 years. If cylinders ever have to be discharged at a time when it has been more than five years since they were pressure tested, they must be retested before recharging. Enclosure (1) to NVIC 6-72 lists the inspection requirements in one concise paragraph: "D.2.". The National Fire Protection Association provides the technical specifics for the inspection: "NFPA 12, Chapter 9.4.3".

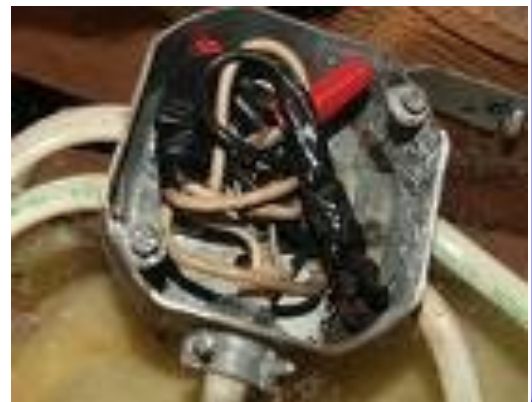
## *Wiring Material and Methods*

Wiring Materials and Methods (Electrical Regulations: 46 CFR 111.60) Wires must be properly installed and connected in accordance with IEEE Std 45 sections 20 & 22 as well as IEC 92-3 and paragraph 8 of IEC 92-352. The use of temporary wiring where equipment must be hard wired is the most common finding (40%) and dead-end wires account for 18% of the inspection deficiencies. Insufficient mounting of cables as they run along bulkheads is also noteworthy. Operators can easily do a self-inspection prior to scheduling the exam. Make sure that all junction boxes have their covers in place (46 CFR 111.81).
